NATIONAL TRANSPORTATION SAFETY BOARD

AIRCRAFT ACCIDENT REPORT

In-flight Breakup Over the Atlantic Ocean
Trans World Airlines Flight 800
Boeing 747-131, N93119
Near East Moriches, New York
July 17, 1996

**NTSB/AAR-00/03
DCA96MA070
PB2000-910403
Notation 6788G
Adopted August 23, 2000**

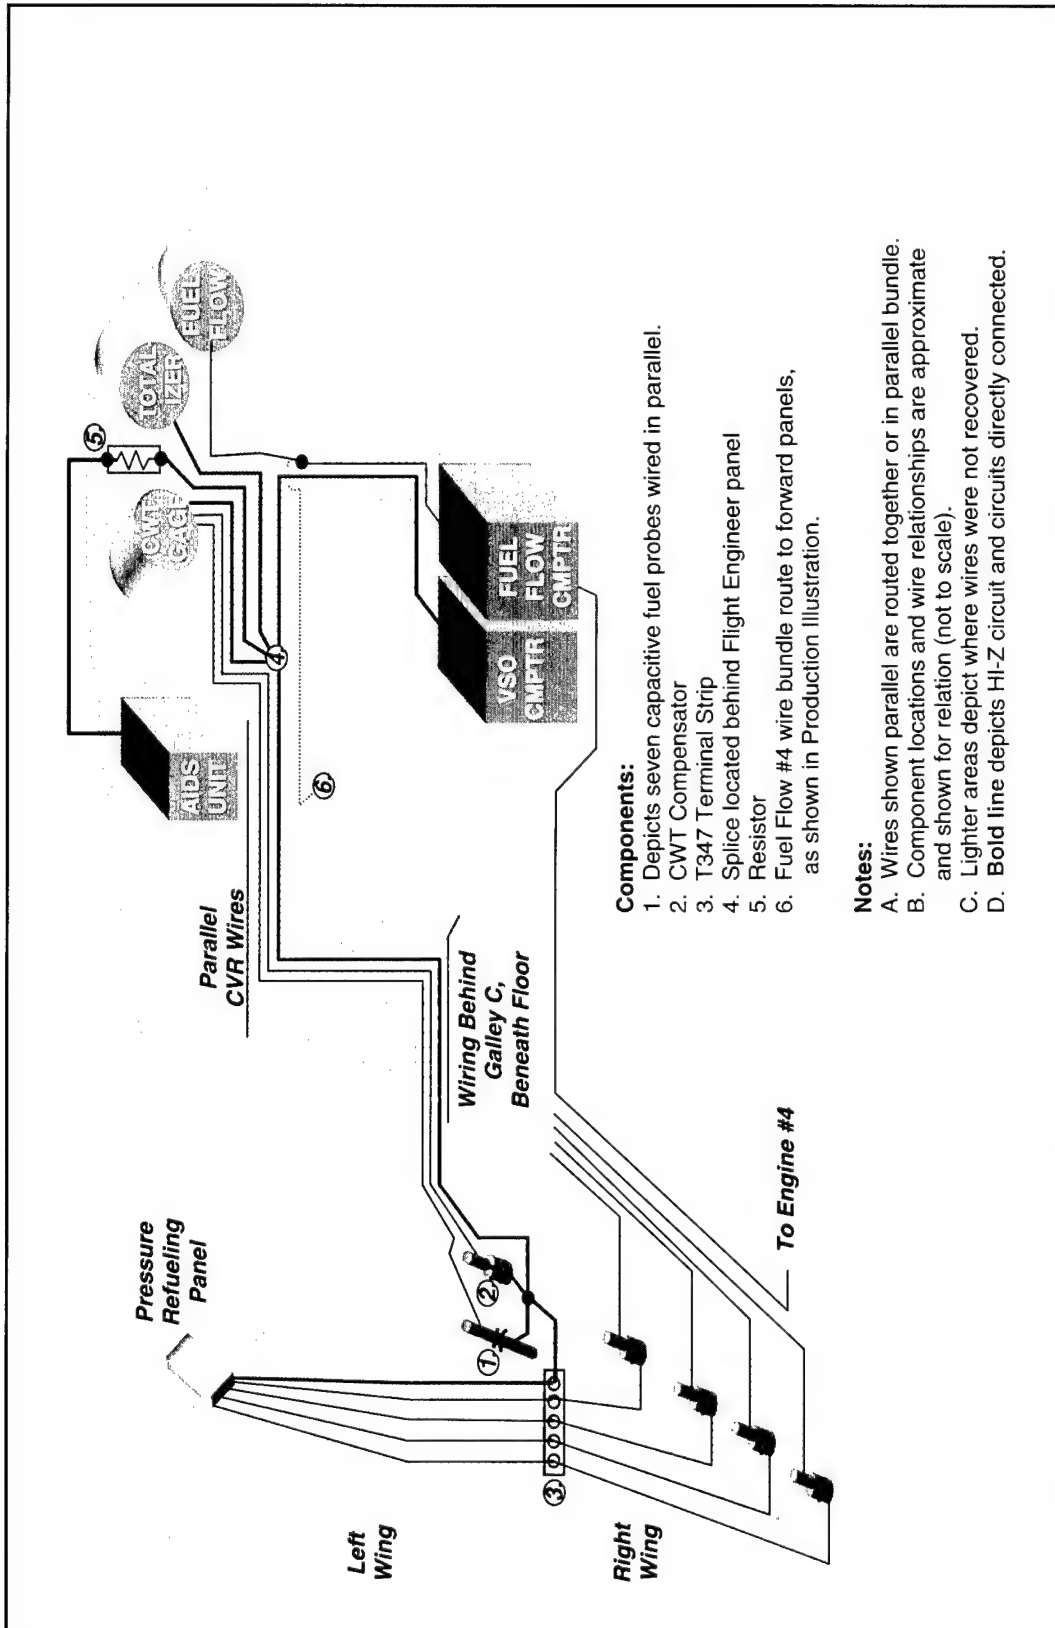
Metal Shaving Abrasion Tests (Dry)

The CWT FQIS wiring in the 747 terminates at common connectors with the fuel quantity indicator, the totalizer gauge, the airborne integrated data system (AIDS), the volumetric shutoff (VSO), and the left wing refueling station; each of these connectors also includes terminating wires from circuits that carry 115 volts.⁶⁰⁵ (See figure 46.) Short circuits in connectors have caused incidents in the past. For example, an October 22, 1995, incident involving roll/yaw oscillations on a 737 near Manchester, England, was attributed to a short circuit in the rudder circuitry of the incident airplane that resulted from lavatory fluid bridging the pins within an electrical conductor.

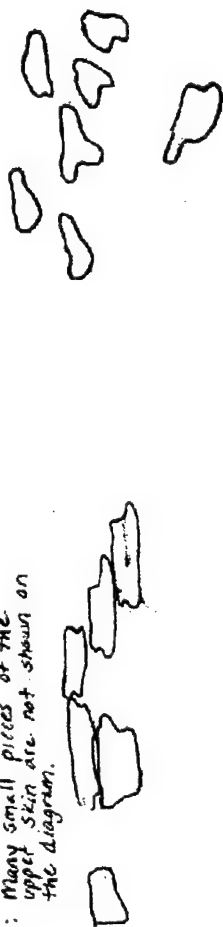
LEFT WING SOOTING PATTERN DIAGRAMUPPER SKIN - INTERNAL SURFACE

NOTE: With the exception of the piece noted, the internal surface of the upper skin is clean. The control surfaces do show sooting and fire damage to the composite parts.

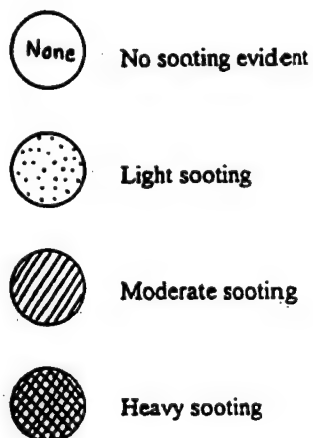
Fuselage sooting diagrams

Surveyed panels are all recovered from the Green debris field and are located from approximately STA 910 to STA 1600.

Aft of STA 1600, no sooting is evident internally. On the exterior, there is light to moderate sooting extending aft along the entire length of the fuselage from approximately the main deck window belt on the RHS to approximately S-8 on the LHS
